Sepik Development Project – Dam Break Risks Assessments

FRHEP Dam Risk Assessment – Technical Report

FRHEP, Frieda River, Papua New Guinea
PanAust Limited

SRK Consulting (Canada) Inc. ■ CAPR003035 ■ September 2024

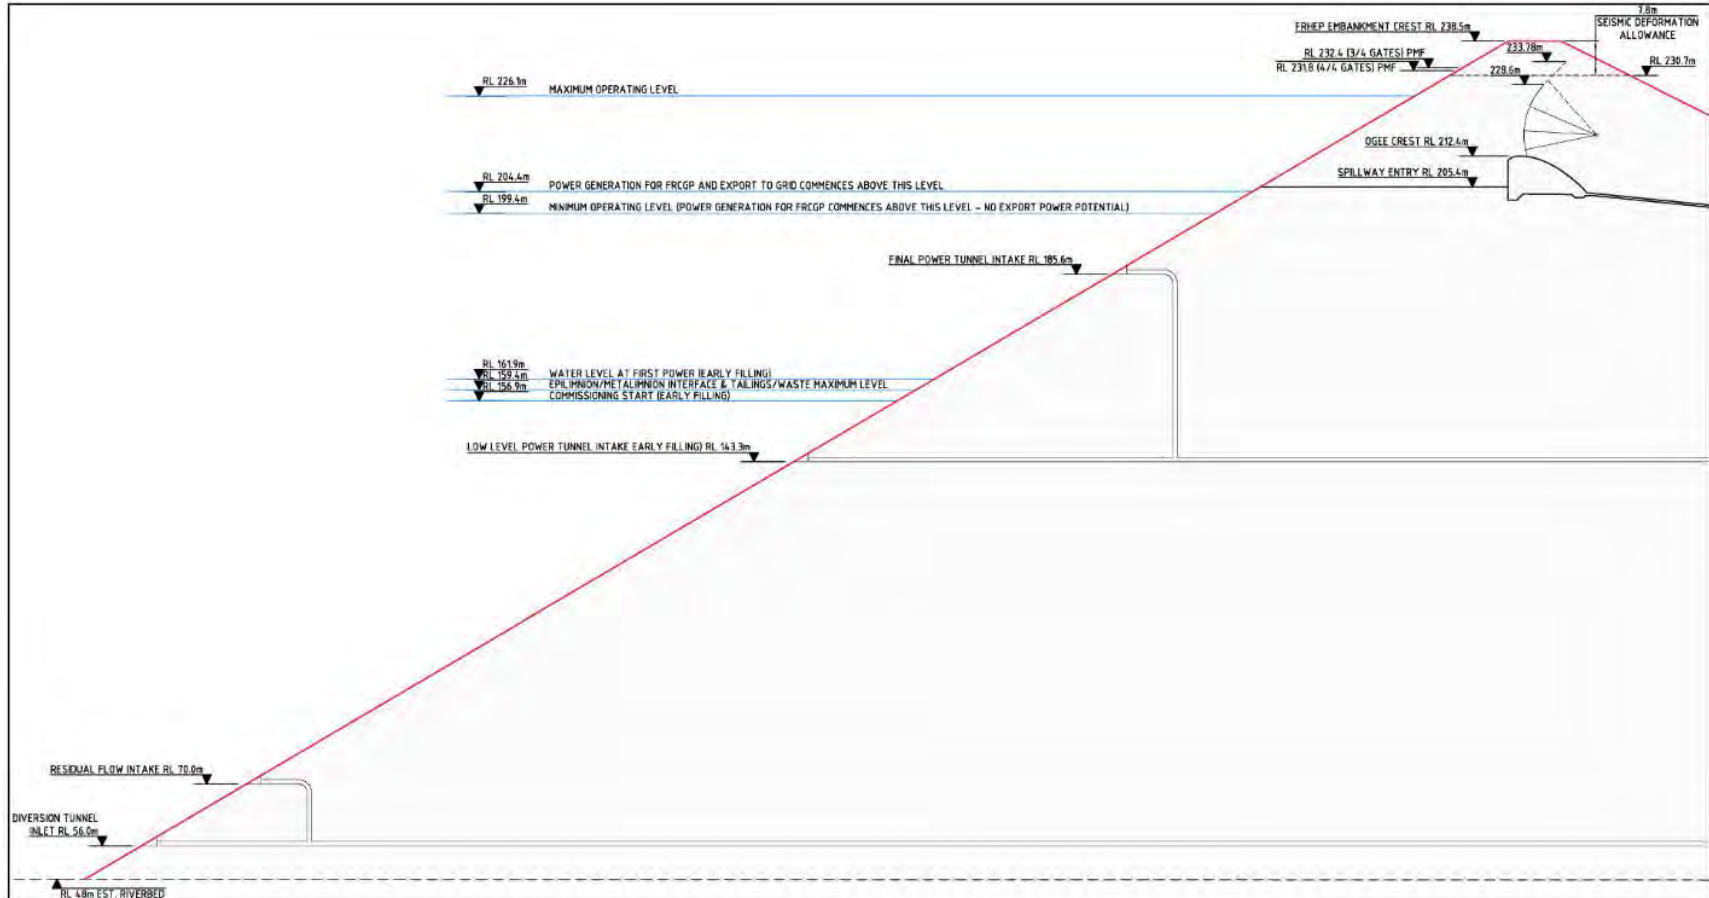
Figure 5: Proposed FRHEP water, waste and embankment elevations

The FHREP reservoir will have a total capacity of roughly 9.6 B m³. Over the life of the mine, a combined volume of 2.13B m³ of mine tailings and waste rock is proposed to be deposited in the reservoir. As indicated in Figure 4, the deposition plan includes keeping the waste rock more than 1000 m from the dam, and placing tailings only in the upper reaches of the reservoir behind barrier of deposited waste rock. Expected water, waste and tailings levels are compared to the FRHEP embankment elevation in Figure 5.

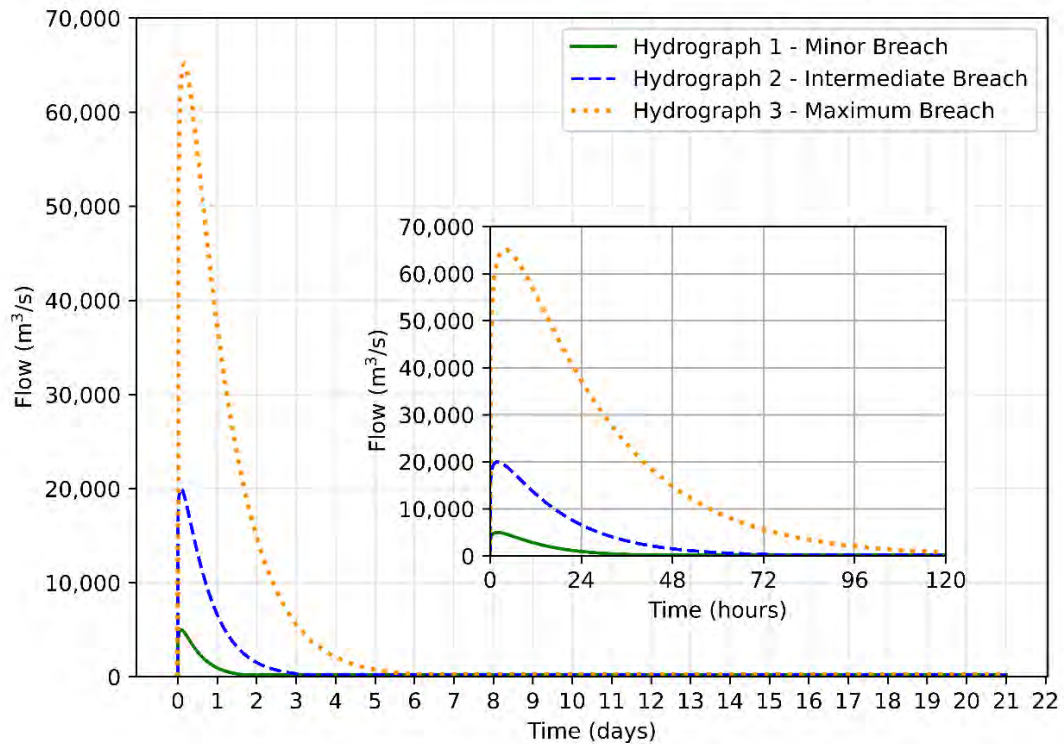
Figure 6: Breach hydrographs for modelled scenarios

There are a number of empirical equations and simplified models available to estimate maximum breach outflow rates (“peak flow” in dam breach jargon) and breach development times (“time to failure”). Unfortunately, the empirical equations were all developed from case histories involving much smaller dams with very different storage configurations than the FRHEP. Therefore a range of possible peak flows was developed using a combination of empirical and ogee crest weir equations, and a range of possible times to failure was selected from literature. It was found that the modelled outflows were far less sensitive to the tested ranges of peak flow and time to failure compared to the assumptions about breach depth and release volume. The assumptions listed in Table 6 and resulting breach hydrographs were adopted, and resulted in the breach outflow hydrographs provided in Figure 6. The hydrographs tails were extended to 21 days from the time of breach to capture both the arrival and dissipation of the breach flood at downstream villages.

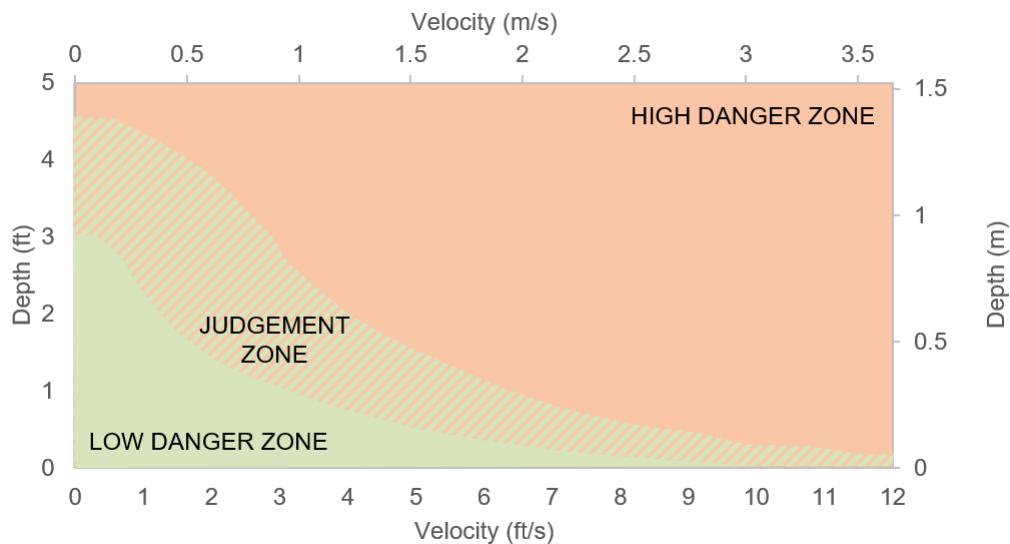
Figure 8: Depth – velocity hazard relationship for adults (from USBR 1988).

2. Compare the maximum depth of the breach outflow to hazard criteria illustrated in Figure 8
 - a. If the maximum depth is greater than 3.5 m (measured as distance above the seasonal high-water level), the breach outflow was considered hazardous to humans.

- b. If the maximum depth above the seasonal high water level is less than 3.5 m, calculate the depth x velocity (DV) value
 - i. If DV is in the 'Low Danger Zone' of Figure 8, the breach outflow flood was considered to be low danger to the community.

- ii. If DV is in either the 'Judgment Zone' or the 'High Danger Zone' of Figure 8, the breach outflow flood was conservatively assumed to high danger to the community.

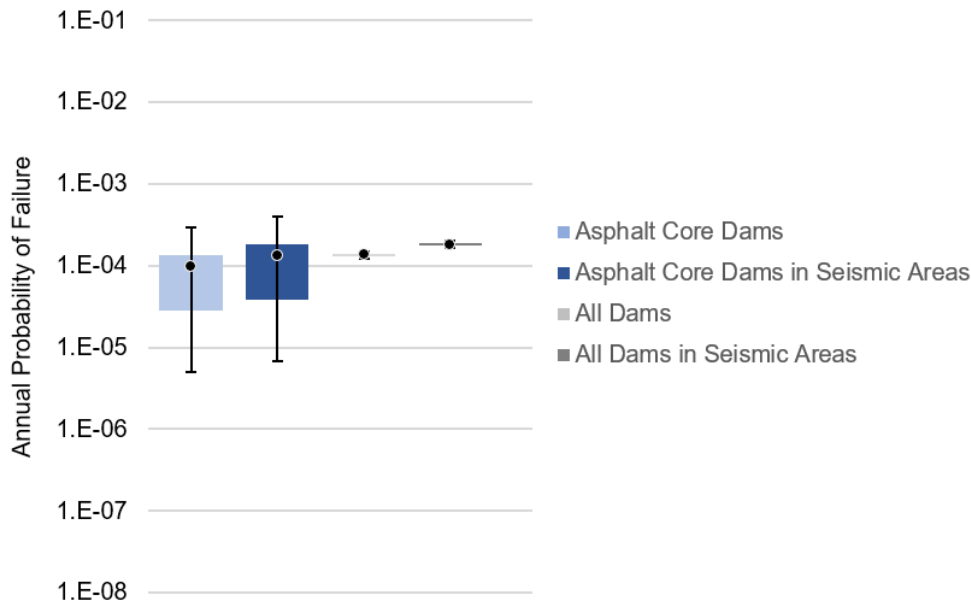
Figure 9: Comparison of probabilities of failure for asphalt core dams and “all dams” with black error bars showing the 95% prediction interval and boxes indicating +/- one quartile from the mean

It is interesting to note the interplay between the very large database of “all dams” and the much smaller database of asphalt core dams. First, even though the asphalt core dam database does not include any failures, failure rates can be estimated using Bayesian statistics. Second, as shown in Figure 9, the fact that no failures have been observed shifts the average failure rate of asphalt core facilities below the average failure rate for all dams. This shift is relatively minor because of the much shorter experience to date with asphalt core dams (~2800 dam-years compared to ~2,000,000 dam years). Third, the 95% prediction interval for asphalt core dams is much wider than that for “all dams”, but this doesn’t mean asphalt core dams are more variable. On the contrary, the wider prediction interval simply reflects the limited global experience with asphalt core dams. If the current trend of no observed failures continues, the predicted range for asphalt core dams will be significantly lower and narrower than shown in Figure 9.

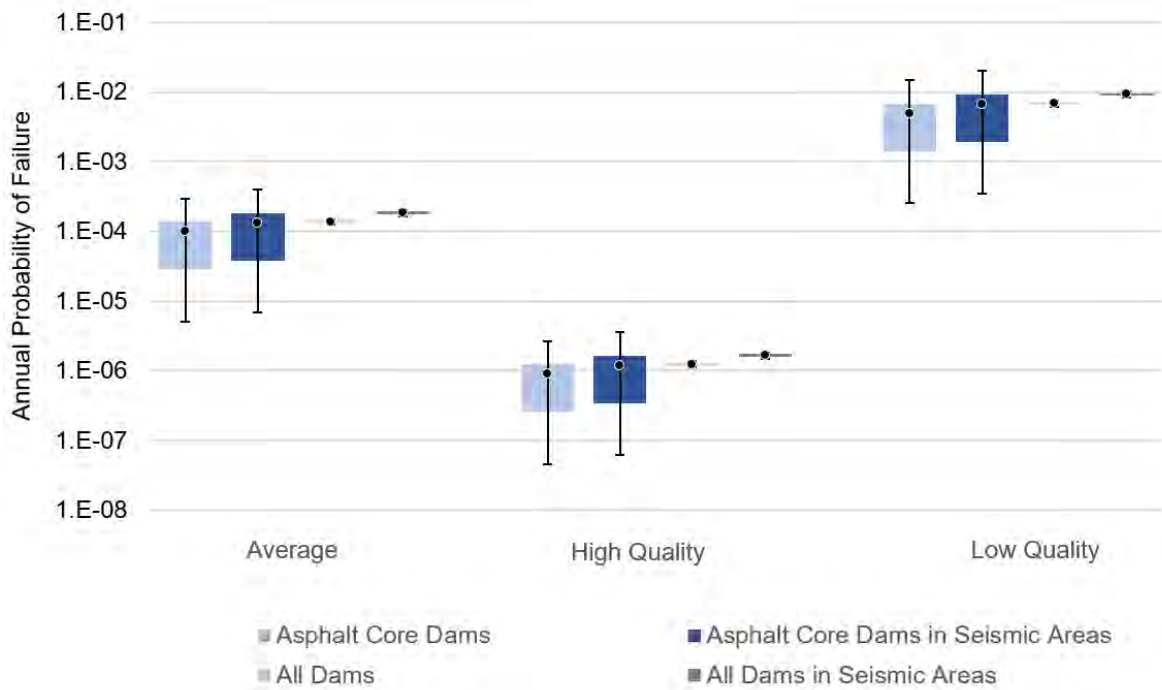
Figure 10: Graphical presentation of estimated probabilities of failure

Figure 10 and Table 18 collates the estimated probabilities of failure presented in the preceding subsections. The first two rows show the “baseline” results, *i.e.* estimated failure rates for all dams higher than 15 m, and failure rates for all asphalt core dams. The next two rows show the increases in estimated failure rates for all dams and asphalt core dams located in seismic areas. The remaining rows show how the estimated failure rates change depending on whether a dam has technical and organizational issues. The ‘high quality’ estimates assume there are no technical or organizational issues, *i.e.* that the quality of design, construction, operations, and governance is consistently high. The ‘low quality’ estimates assume there are both technical and organizational issues, *i.e.* that the quality of design, construction, operations, and/or governance is poor.

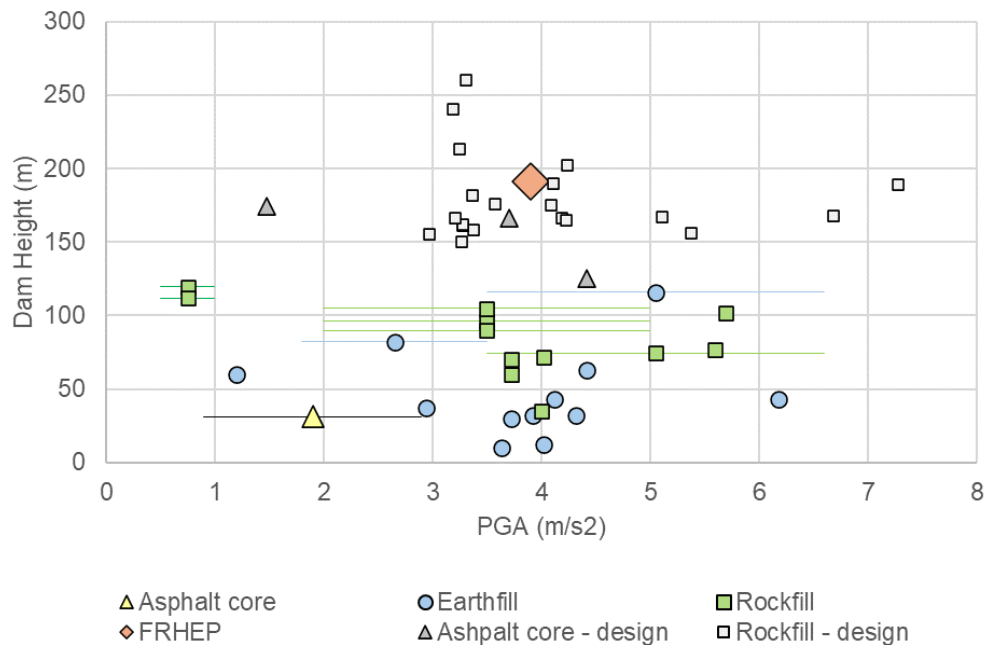
Figure 14: Dams that performed well in significant earthquakes

The information in Section 3.1.2 about dams that have experienced significant seismic events with “none to minor damage” is summarized in Figure 14, which compares each dam’s height to the measured or estimated PGA that it experienced. (Dam names and locations can be found in Table 11.) In addition, the open symbols in Figure 14 represent dams that have been constructed in seismic regions but not yet subjected to a significant earthquake. (Since those dams are not listed in Table 11, they are identified in the Figure 14 notes.) The position of the proposed FRHEP embankment is indicated by the orange symbol in Figure 14, and two patterns are noteworthy. Firstly, comparing the FRHEP symbol to the coloured shapes representing case histories of seismic performance shows that many dams have survived earthquake PGAs greater than the FRHEP OBE, but those dams are all much lower in height than the proposed FRHEP embankment. Secondly however, there are several dams elsewhere in the world that are in the same height range as the FRHEP embankment, and have been designed and constructed for seismic conditions similar to those at the FRHEP.

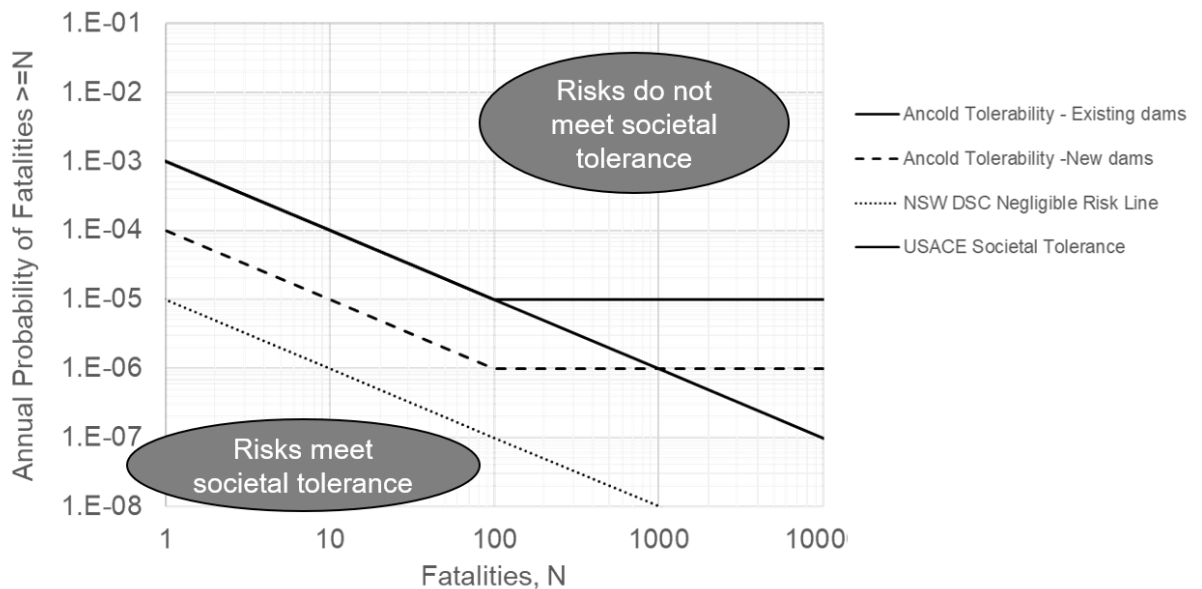
Figure 16: Example F-N plot

The example provided in Figure 16 is referred to as an “F-N plot”. The horizontal axis provides a measure of impact, in this case the estimated number (N) of fatalities, typically on a logarithmic scale. The vertical axis indicates the probability or frequency (F) of those impacts, again on a logarithmic scale. Tolerability thresholds are typically shown as lines on the plot and vary by region and jurisdiction. Risks are generally considered acceptable when they plot below these thresholds, and unacceptable when they plot above. The F-N plot in Figure 16 includes threshold tolerability lines proposed by the US Army Corps of Engineers, the Australian National Committee on Large Dams, and the New South Wales Dam Safety Committee. Other operators and regulators of large dams propose very similar tolerability lines.

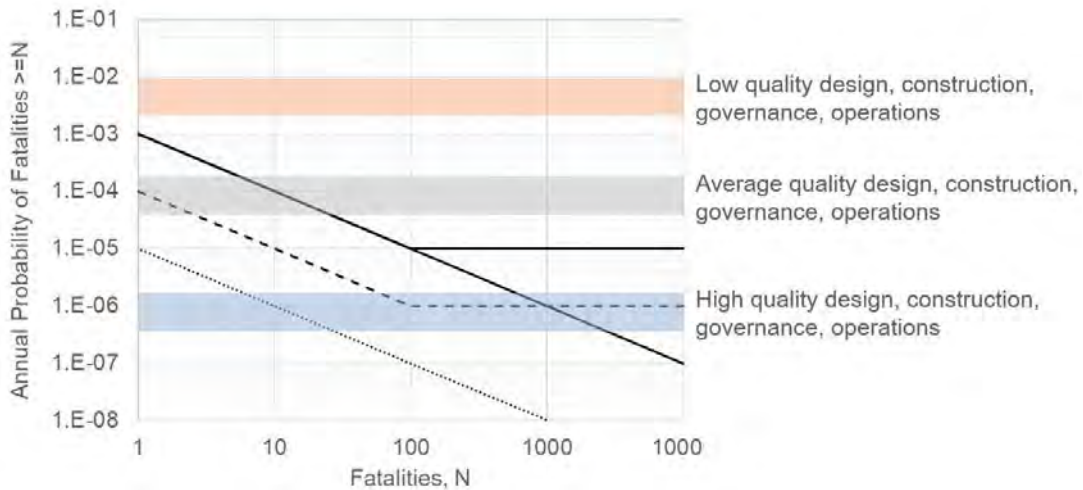
Figure 17: Probability of failure ranges for FRHEP embankment shown on F-N plot

As discussed earlier, the likelihoods of failure are driven by the quality of investigation, design, construction, and governance. Figure 17 shows the ranges of estimated FRHEP failure probabilities plotted in the F-N format. It shows that FRHEP risks could range from much worse to a little better than global averages depending on quality of design, construction, operations, governance and getting to a range of acceptable failure likelihoods requires these all be the “best case”.

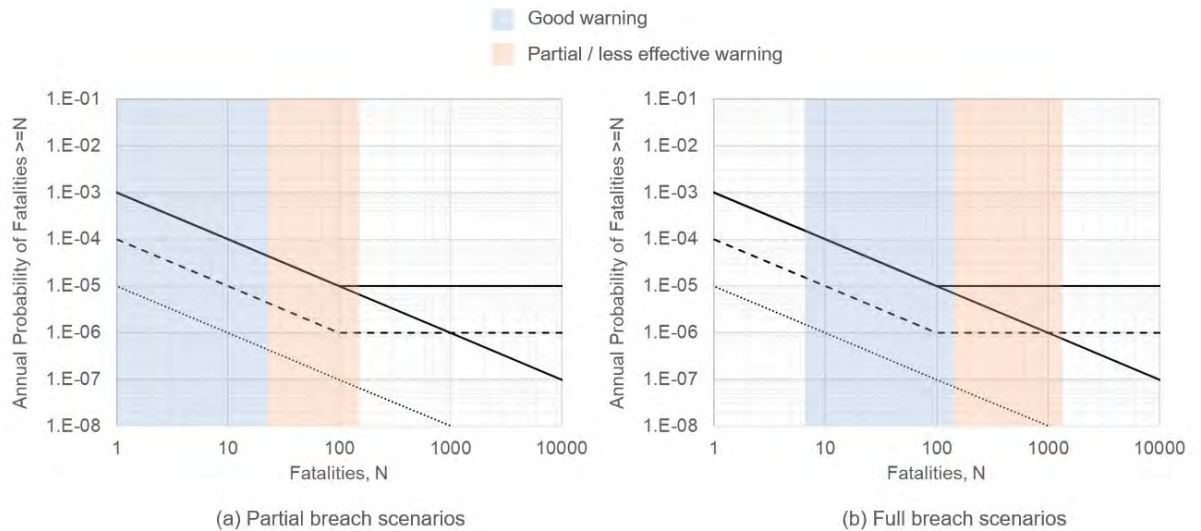
Figure 18: Fatality ranges for FRHEP embankment breach outflow flood shown on F-N plot

Figure 18 plots the fatality estimates in the F-N format. The orange boxes indicate the range of potential fatalities associated with partial or less effective warning and evacuation and the green boxes show the ranges associated with good warning and evacuation. There are two sets of plots covering partial and full breaches. It shows that reducing the potential for fatalities and shifting left on the plot requires effective notification and response.

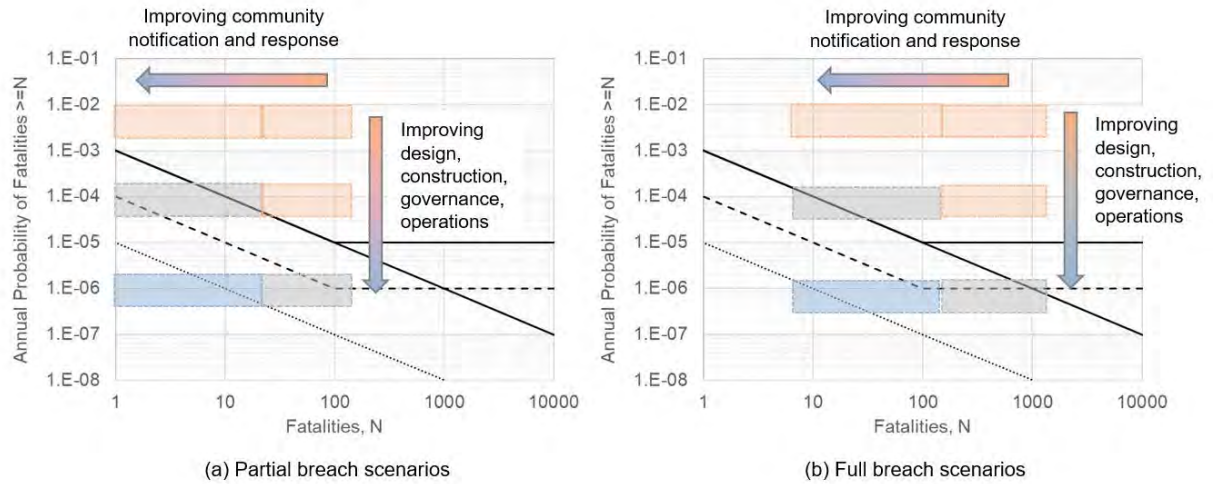
Figure 19: Combined F-N results

Figure 19 combines the FRHEP embankment failure probability and fatality estimates. The first observation is that the FRHEP embankment can present risks that range from intolerable to tolerable or even negligible. The arrows in Figure 19 indicate the major controls on failure probability and consequence severity. It is clear that ensuring the FRHEP embankment remains within tolerability

limits will require BOTH high quality design, construction, operations, governance AND an effective warning and community response system.

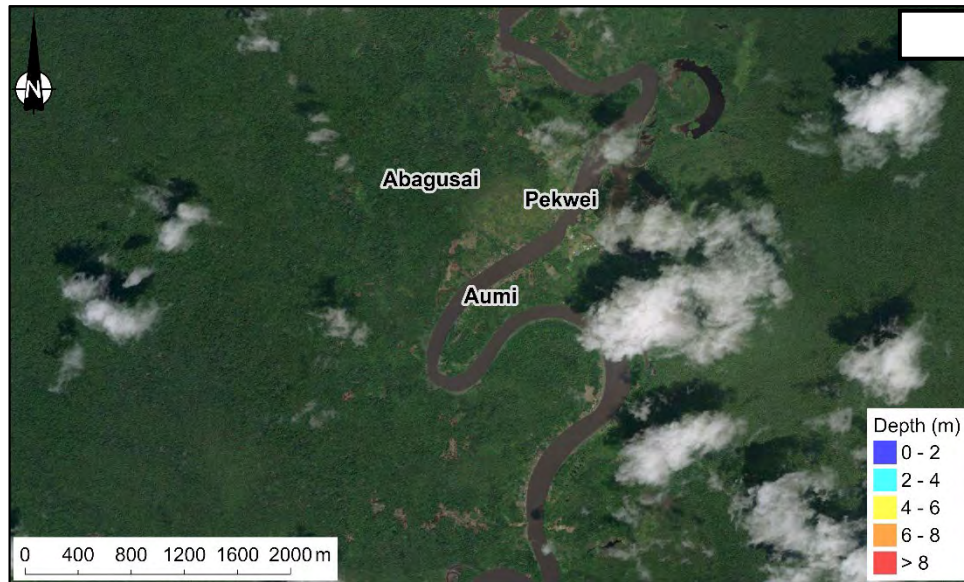
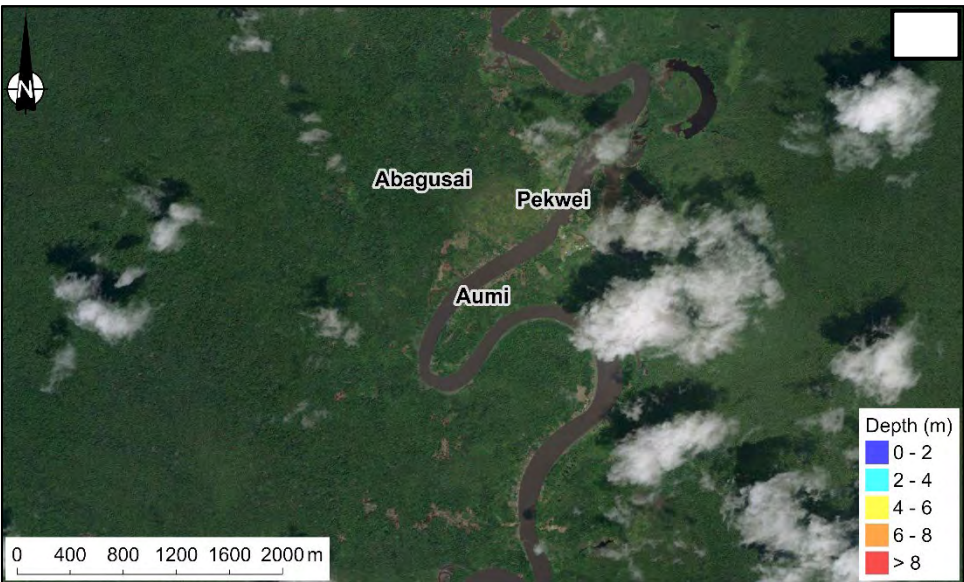
Scenario	(1) 2m Breach – Seasonal Low Initial Water Level	(2) 10m Breach - Seasonal Low Initial Water Level	(3) 10m Breach – Seasonal High Initial Water Level	(4) 66.7m Breach (Max) – Seasonal Low Initial Water Level
Release Volume (m ³)	0.26 Bm ³	1.24 Bm ³	1.24 Bm ³	6.37 Bm ³
Maximum Depth, [depth above seasonal high-water level], velocity ¹	Not Inundated	Not Inundated	2.93, [-], 0.01	3.21, [-], 0.26

- Notes:
1. Red shading indicates community is in high danger zone for the breach event. Green shading indicates the community is in a potentially non-hazardous zone for the breach event.
 2. Damage to infrastructure may still occur for areas considered potentially non-hazardous zones (shaded in green).
 3. Community locations are based on coordinates provided in SRK (2018) and should be considered approximate.

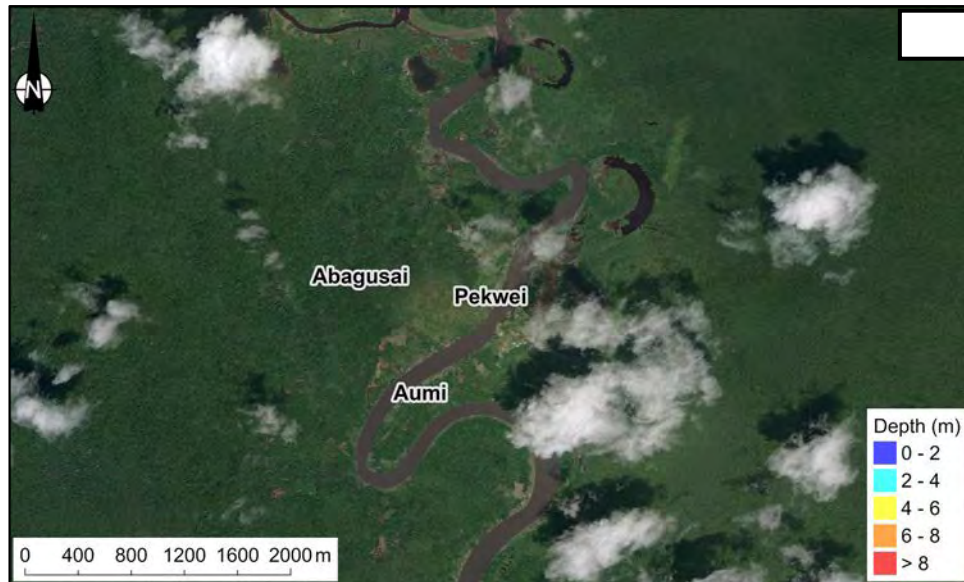
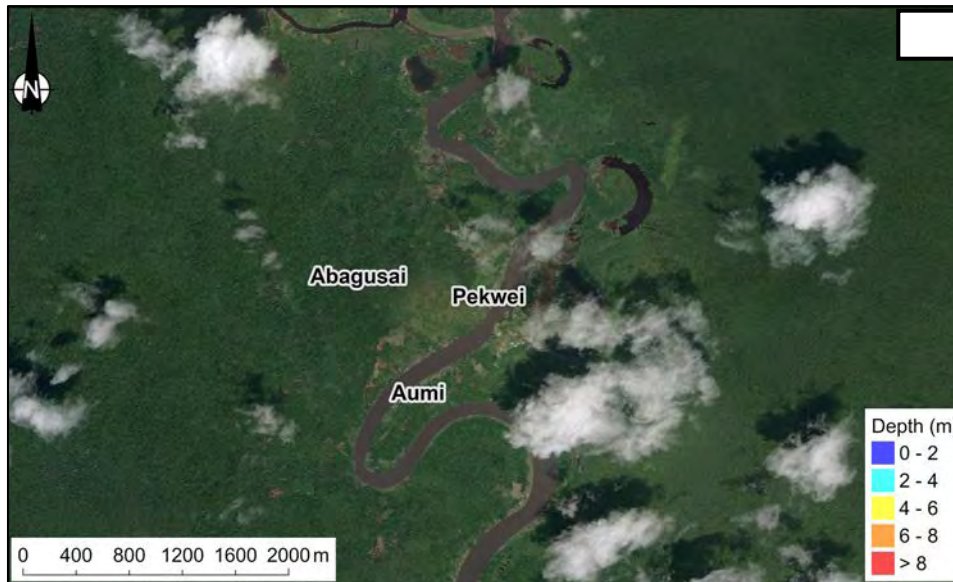
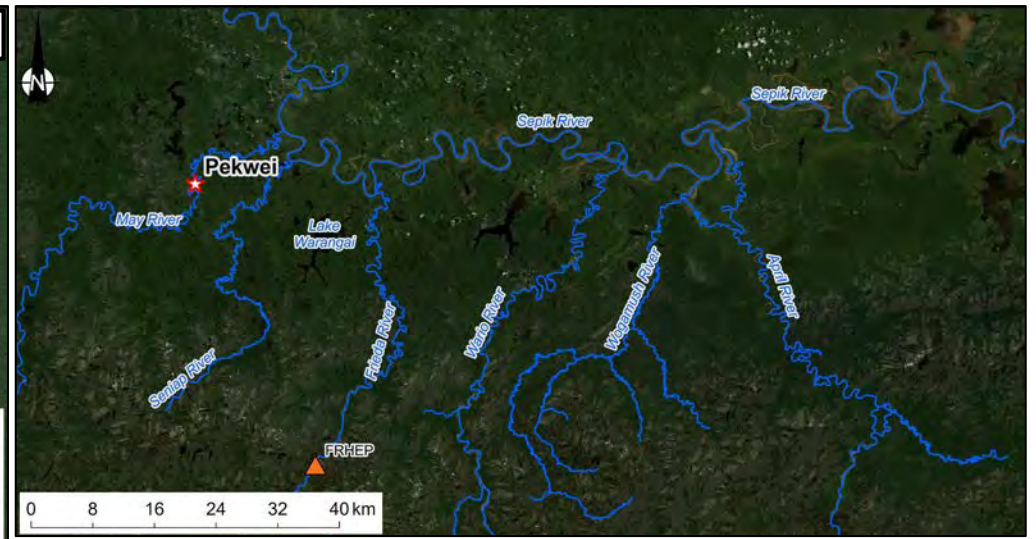
FRHEP Dam Risk Assessment Technical Report		
		Pei		
Job No: CAPR003035 Filename: FriedaRiver_VillagebyVillageAssessment.pptx	Frieda River Dam	Date: May 2024	Approved: ABL	Figure: X.X

Scenario	(1) 2m Breach – Seasonal Low Initial Water Level	(2) 10m Breach - Seasonal Low Initial Water Level	(3) 10m Breach – Seasonal High Initial Water Level	(4) 66.7m Breach (Max) – Seasonal Low Initial Water Level
Release Volume (m ³)	0.26 Bm ³	1.24 Bm ³	1.24 Bm ³	6.37 Bm ³
Maximum Depth, [depth above seasonal high-water level], velocity ¹	Not Inundated	Not Inundated	7, [3], 0.01	7.28, [3.28], 0.14

- Notes:
1. Red shading indicates community is in high danger zone for the breach event. Green shading indicates the community is in a potentially non-hazardous zone for the breach event.
 2. Damage to infrastructure may still occur for areas considered potentially non-hazardous zones (shaded in green).
 3. Community locations are based on coordinates provided in SRK (2018) and should be considered approximate.
